HEADQUARTERS  
AERONAUTICAL SYSTEMS DIVISION  
AIR FORCE SYSTEMS COMMAND  
UNITED STATES AIR FORCE  
WRIGHT-PATTERSON AIR FORCE BASE, OHIO

Technical Memorandum  
ASNP-TM-61-28  
24 November 1961

QUALIFICATION TESTING OF THE  
PACIFIC SCIENTIFIC COMPANY'S ALTITUDE  
SENSITIVE ACTUATORS, NOS. 1201117-0,  
1201118-0 AND 1201119-0

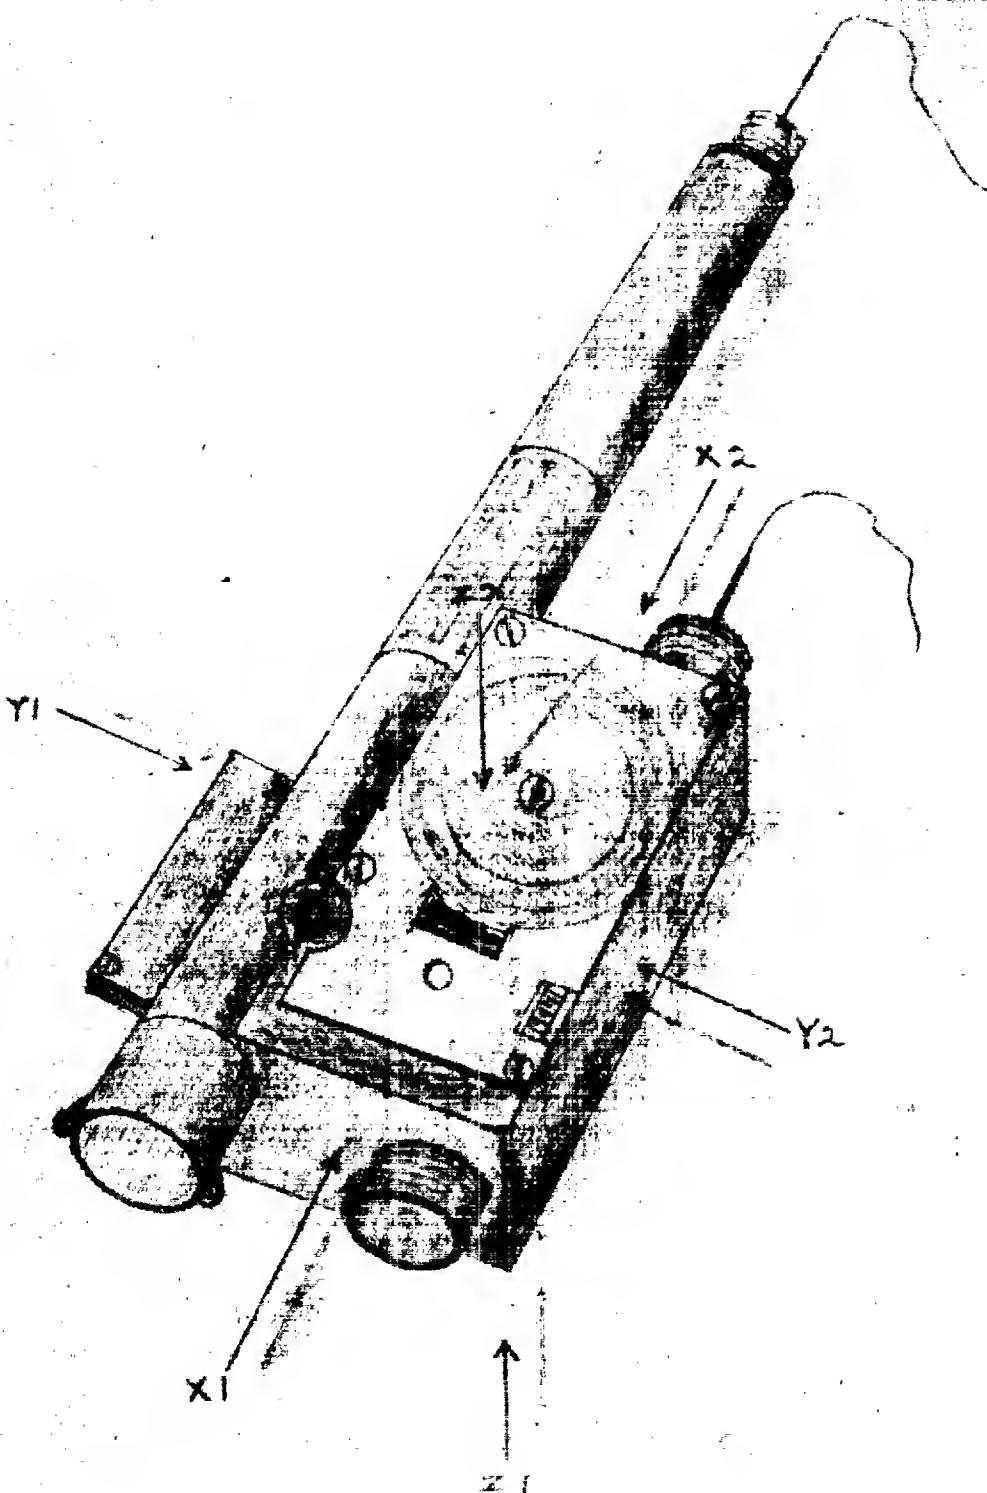
FIG-1

Figure 1  
Automatic Parachute Actuators
